# Cause and Measures of Transverse Corner Crack in Hull Structural V-Containing Steel CC Slabs

Shougang Iron and Steel Group Corp.

**Abstract:** The reasons of transverse corner crack in hull structural steel CC (continuous casting) slab have been analyzed in this paper. The influence of steel-making, continuous casting technics and micro alloy element has been discussed. The improving measures are put forward and better effects have been obtained.

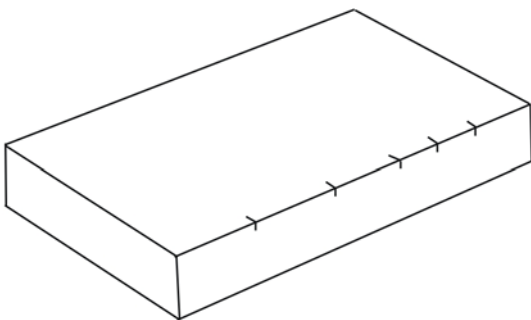
Fig. 1 The sketch of transverse corner cracks.

The character of transverse corner crack was showed as figure 1 (sketch). The transverse corner crack of the slab in the production was showed as figure 2. The transverse corner crack in Shougang hull structural slab often happened at inner arc of the slab, also at the deep of oscillation mark. The cracks took place at the corner and extended to the broad and narrow face. The length of the crack was about  $2\sim 10\text{mm}$ , and the depth of it was about  $2\sim 5\text{mm}$ .
